# Post Incident Report

## Major Incident Management

| Incident Title | Canning Town - Fibre Break - Impacting 34 B2B |
| Incident Reference | F012462801 |

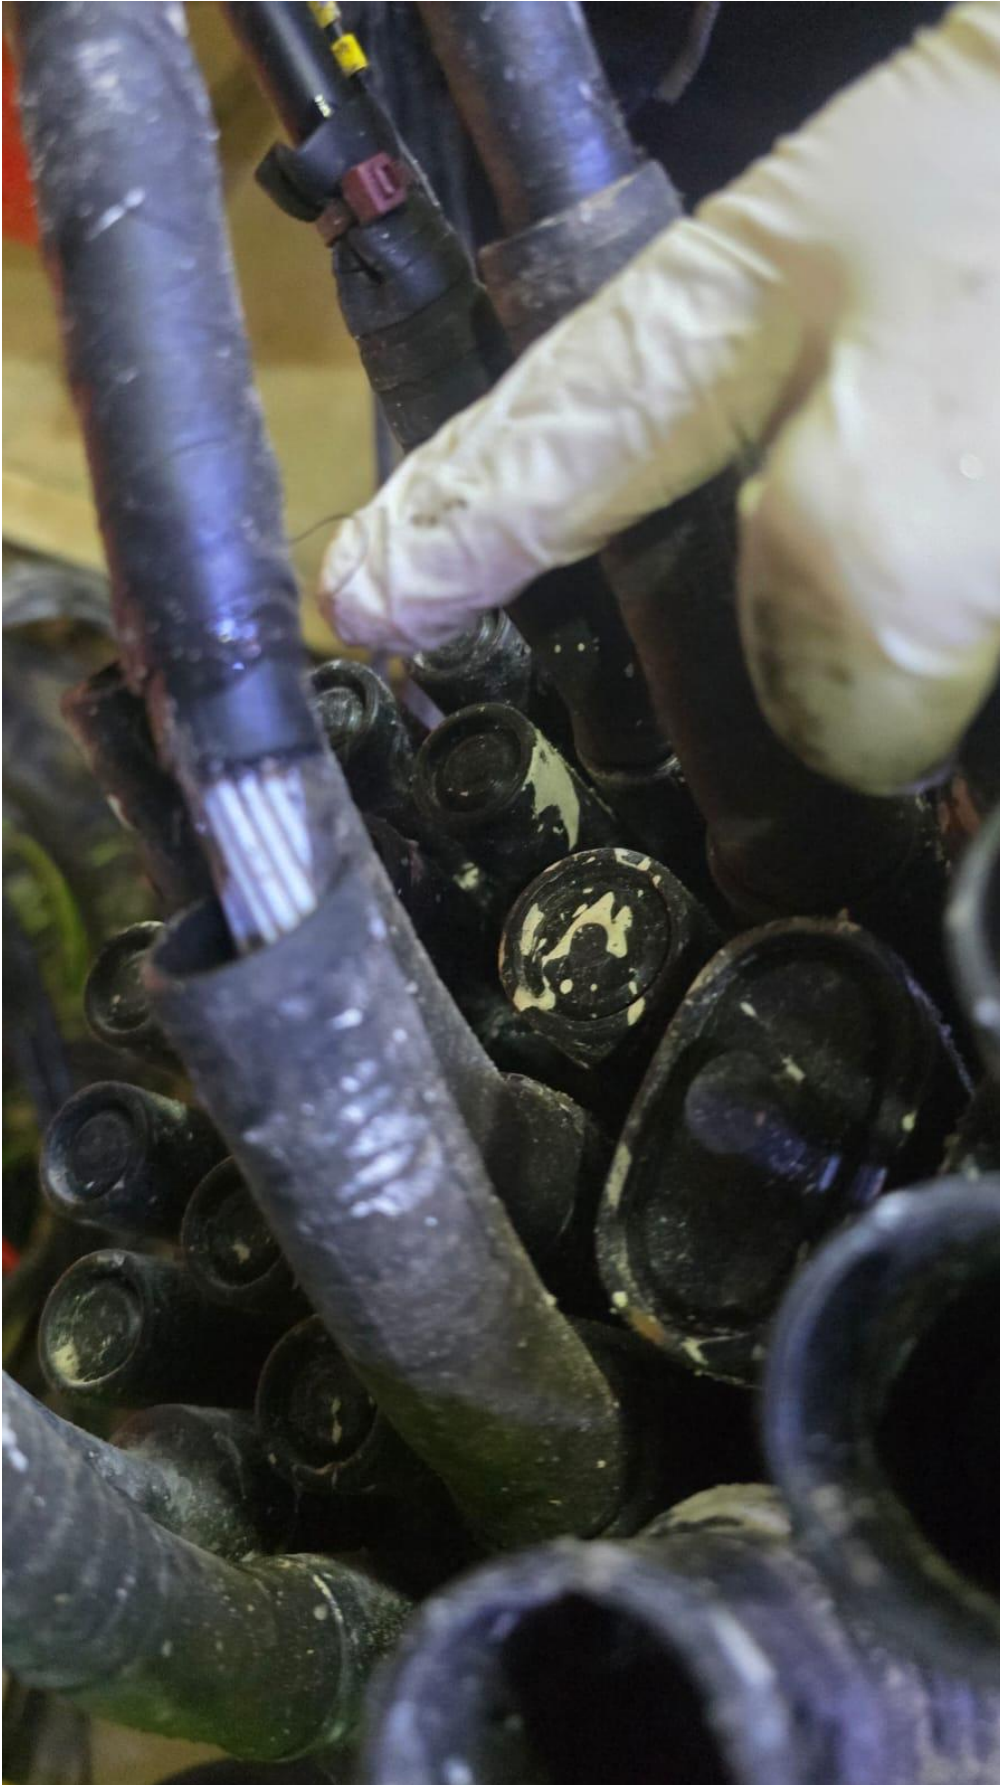
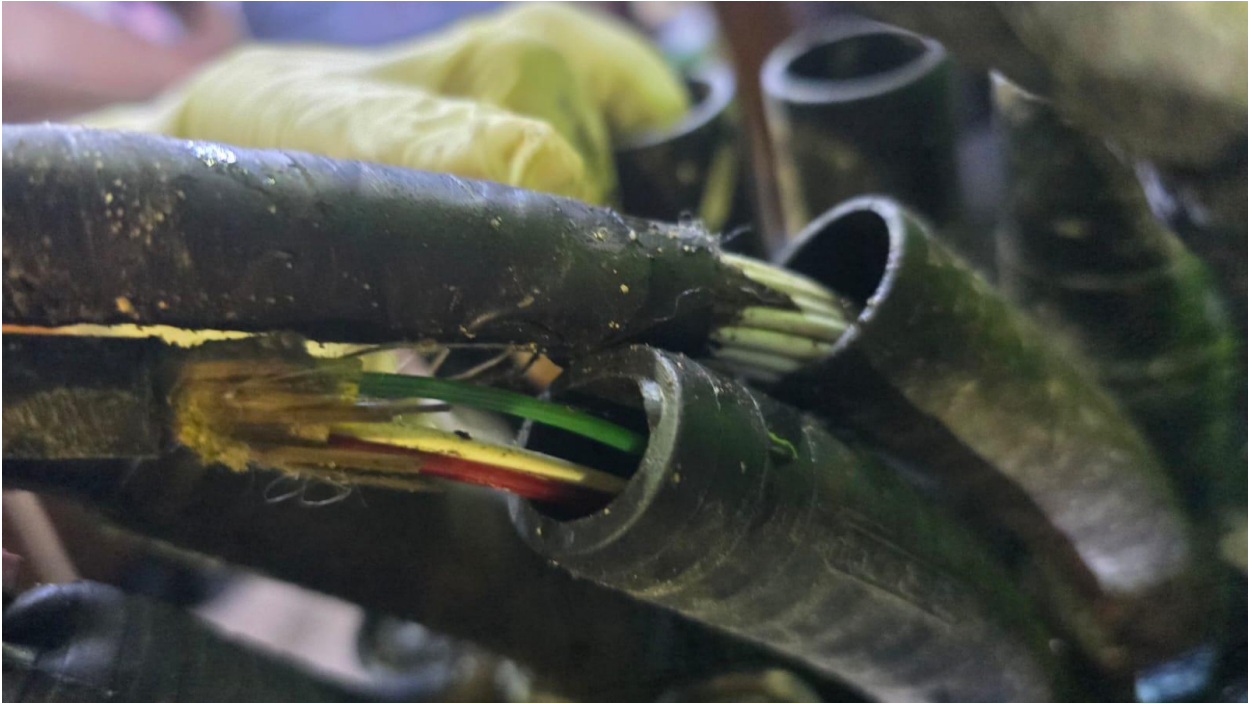
At 01:26, the Network Engineer advised that POPL-06-JZ03 was in extremely poor condition, with exposed tubes. As a result, the Splicers were required to work with extreme care to avoid disturbing the remaining fibres. One spare fibre had been located, and they were continuing to search for the second spare fibre. The fibres originating from VMO2 Dalston had been identified within the joint, and once the final spare fibre had been located, repair work would commence.

Problem Record NPR00024003 raised and assigned to the Network Operations Manager (NOM) to investigate root cause. It likely to be rodent damage as that was noticed during the fix work but this is to be formally confirmed once the full investigation has concluded.

18:51 - NE identified spares from the Dalston to joint in Whitechapel Road but they all stop at the break location. Splicer continues to test spares to see if any are viable. Rodent damage suspected.

Services moved onto spare fibres at VMO2 Canning Town and VMO2 Dalston to avoid damage between joint POPL-06-JZ04 (junction Commercial Road and Henriques Street) and joint POPL-06-JZ04A (45 Whitechapel Road.)

- Incident Action PIR0042559-A1 has been raised and assigned to the NOM to update fibre records.
- Incident Action PIR0042559-A2 has been raised and assigned to the NOM to add joint POPL-06-JZ03 to the High Risk Register.
